NSWC TR 85-22

SAFETY TESTS OF ADC MK 3

15 JANUARY 1985

NAVAL SURFACE WEAPONS CENTER

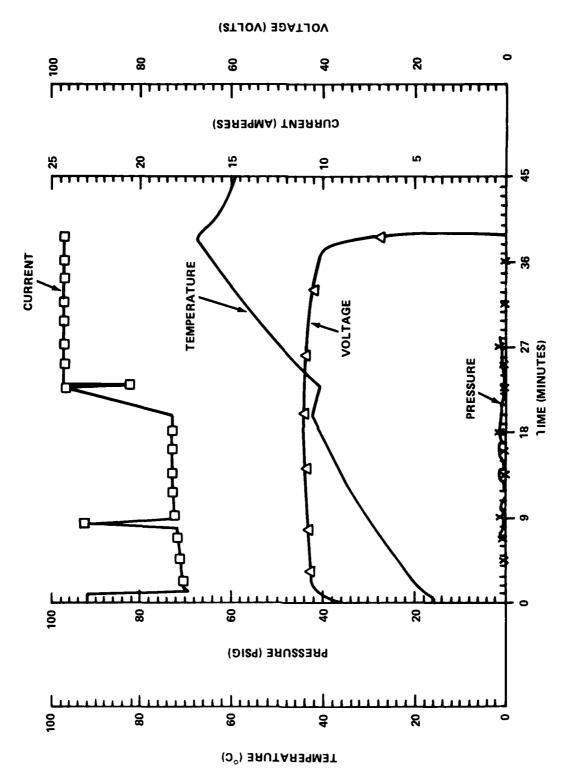
Test Number 1 was a forced discharge of the battery inside the ADC Mk 3 unit. All fuses were in place for this test. A plot of temperature, pressure, current, and voltage versus time is shown in Figure 6. Initially, the discharge current was set at 23 amperes. The battery was not discharged at 30 amperes due to a power-supply current limitation of 24.5 amperes. After approximately one minute, the power supply circuit breaker opened and the current dropped to 18 amperes. Repairs were completed and at 19 minutes the power supply was again supplying current. The current at this point was 24.5 amperes, or approximately 8.2 amperes per parallel string. At 37.5 minutes the battery circuit opened. At this time the maximum battery temperature recorded was 68.1°C which is near the set point of 70°C of the thermal fuses. A post-mortem indicated that two of the three thermal fuses opened. In addition, the 15-ampere electrical fuse in the leg which had the thermal fuse intact also opened. This is consistent with the fact that after the two thermals opened, all the current (23 amperes) passed through the leg with a thermal fuse and a 15-ampere fuse. No ventings were observed during this test.

FORCED DISCHARGE OF LITHIUM BATTERY INSIDE ADC MK 3 UNIT (CURRENT, VOLTAGE, PRESSURE, AND TEMPERATURE ARE PLOTTED AS A FUNCTION OF TIME. ALL SAFETY DEVICES WERE PRESENT IN THE BATTERY.) FIGURE 6.

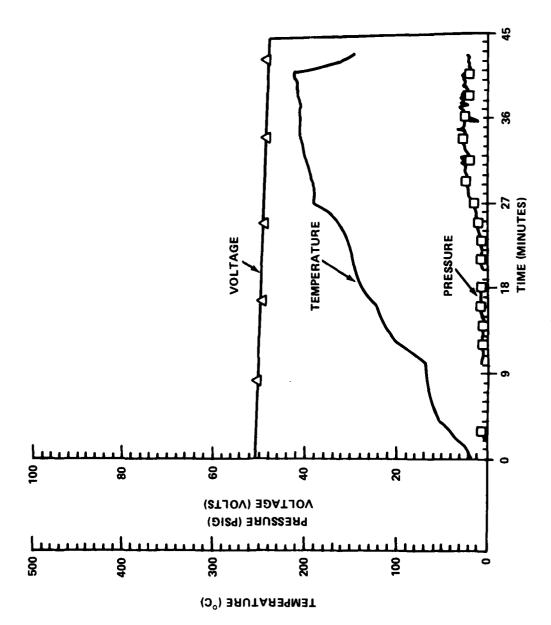
Test Number 2 was the heating of the complete battery pack at approximately 10°C/minute inside the ADC Mk 3. Voltage, temperature, and pressure were monitored throughout the run. Pressure measurements indicated the venting of cells about at 19 minutes (e.c. = 150°C) into the run continuing up to 44 minutes. At no time did the pressure exceed 15 psig. Temperature, voltage, and pressure versus time are plotted in Figure 7. Figure 8 shows the "Roberts" pressure relief valve inside the tail section of the ADC Mk 3 before testing. Figure 9 shows the tail section after venting has taken place through the relief valve.

FIGURE 7. HEAT TAPE TEST ON ADC MK 3 (VOLTAGE, PRESSURE, AND TEMPERATURE ARE PLOTTED AS A FUNCTION OF TIME.)

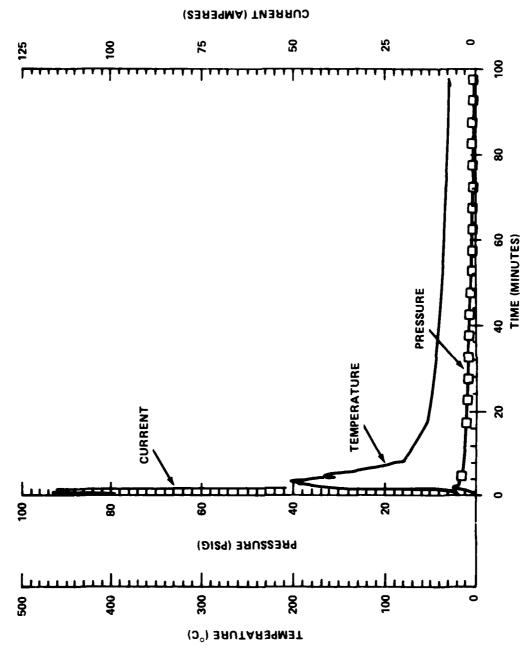
Test Number 3 consisted of shorting the battery inside the ADC Mk 3 with all fuses and diodes bypassed. The value of the impedance resistance of the short circuit was 0.02 ohm. A summary of the data is presented in Figure 10. The current originally rose to 94 amperes. After two minutes the battery opened due to a high current failure of the connecting tabs. The battery vented producing approximately 8 psig at which point the "Roberts" valve opened. The maximum temperature observed was about 200°C. As in previous tests, the "Roberts" valve kept the pressure below 15 psig in the ADC Mk 3 unit.

SHORT CIRCUIT ON ADC MK 3 BATTERY INSIDE THE ADC MK 3 UNIT (ALL PROTECTIVE DEVICES SUCH AS FUSES OR DIODES WERE REMOVED FROM THE BATTERY FOR THE TEST. THE PLOT SHOWS CURRENT, PRESSURE, AND TEMPERATURE.) FIGURE 10.

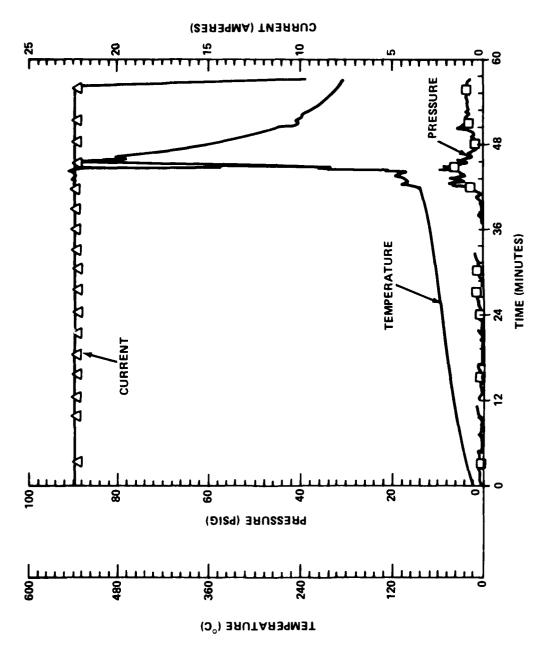
Test Number 4 consisted of a forced discharge at a constant current of 22.5 amperes of the battery inside the ADC Mk 3 as configured for shipping. All fuses and diodes were removed for this test. Venting commenced at approximately 40 minutes at which time the temperature rose rapidly to 500°C. The maximum pressure was 10 psig. The "Roberts" valve operated properly in this case also. A summary of the data is presented in Figure 11.

FIGURE 11. CONSTANT CURRENT DISCHARGE AT 22.5 AMPERES OF THE ADC MK 3 BATTERY (AS CONFIGURED FOR SHIPPING SEE FIGURE 4)(ALL SAFETY DEVICES WERE REMOVED FOR THIS TEST. CURRENT, PRESSURE, AND TEMPERATURE ARE PLOTTED AS A FUNCTION OF TIME.)

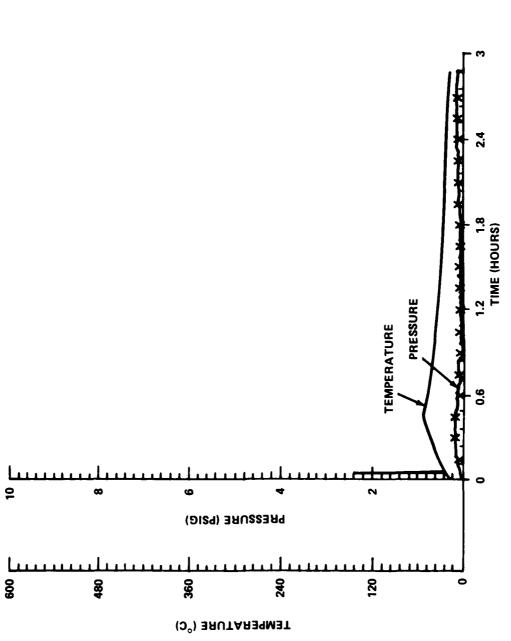
Test Number 5 consisted of a charging test of the full battery pack after removal of approximately 50 percent of the capacity. The capacity was removed at a constant current of 21.5 amperes. Charging commenced with the current and voltages limited to 21.5 amperes and 52 volts, respectively. These limits were set at the electrical fuse value and the open circuit voltage of the battery. The charging current fell from 3.0 amperes to approximately 100 milliamperes in 10 minutes. The test was terminated after four hours. No venting occurred during this test. A summary of the charging test data are presented in Figure 12.

The charging current and voltage were subsequently increased to 21.5 amperes and 64 volts, respectively. After approximately 20 minutes, an explosion occurred which blew off the end cap and dislocated or shifted the target. The explosions of individual cells continued for three minutes. It should be emphasized that charging current was no longer being applied to the cells that exploded after the initial explosion. The highest temperature recorded was 50°C.

FIGURE 12. CHARGING OF ADC MK 3 LITHIUM BATTERY AS CONFIGURED FOR SHIPPING AFTER 50 PERCENT OF THE CAPACITY HAD BEEN REMOVED AT 21.5 AMPERES (THE VOLTAGE AND CURRENT WERE LIMITED TO 52 VOLTS AND 21.5 AMPERES, RESPECTIVELY.)

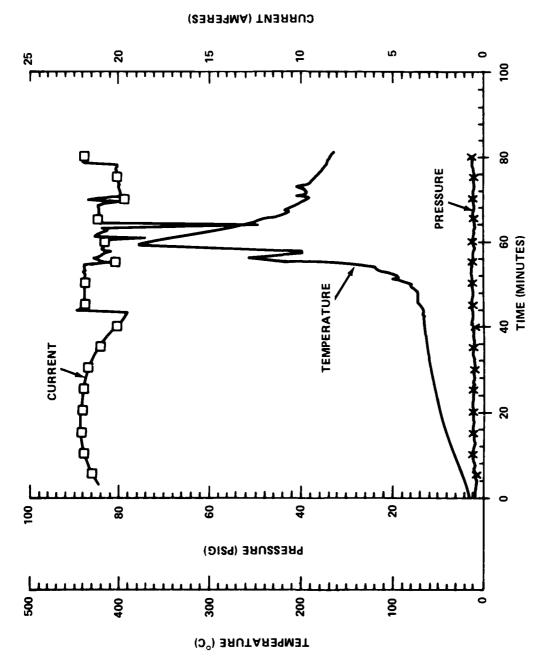
Test Number 6 was a forced discharge of the battery in the launcher with the plastic dust cover in place. The battery vented quietly after about 50 minutes into the test. Smoke appeared around the dust cover. The pressure never rose above a few psig. No adverse reactions were observed. The maximum temperature recorded was approximately 350°C. A summary of this test is presented in Figure 13.

CONSTANT CURRENT DISCHARGE AT 21.5 AMPERES OF THE ADC MK 3 LITHIUM BATTERY AS CONFIGURED FOR SHIPPING (NO PROTECTIVE DEVICES WERE IN THE BATTERY. CURRENT TEMPERATURE, AND PRESSURE ARE PLOTTED AS A FUNCTION OF TIME.) FIGURE 13.

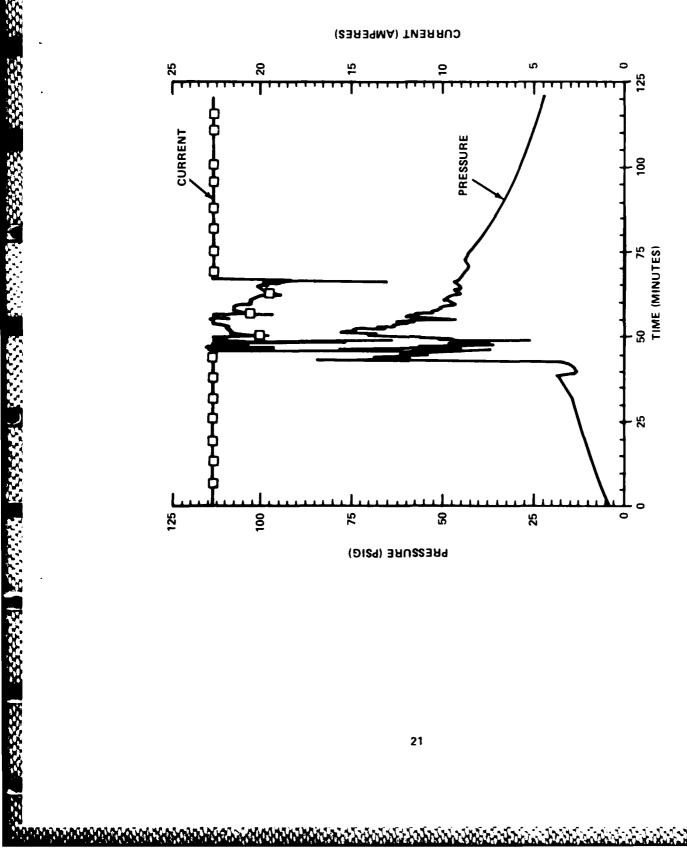
Test Number 7 was a forced discharge in the launcher with the gas generator attached. The battery vented mildly and caused no adverse effects to the unit. The pressure in the launcher reached 120 psig because of the lack of a pressure relief valve. However, the gas in the launcher was contained without incident. A summary of this test is presented in Figure 14.

FIGURE 14. CONSTANT CURRENT DISCHARGE AT 22.5 AMPERES OF ADC MK 3 INSIDE LAUNCHER AS CONFIGURED FOR LAUNCH (SEE FIGURE 5)(ALL BATTERY PROTECTIVE DEVICES WERE REMOVED. CURRENT AND PRESSURE ARE PLOTTED AS A FUNCTION OF TIME.)

Gas was properly released through the "Roberts" pressure relief valve supplied with the ADC Mk 3. No external fire or flame was observed. Test 6 resulted in the escape of gas at the dust cover. No measurable pressure rise in the launch tube was observed. Test 7 resulted in a pressure in excess of 110 psig in the launch tube. According to information provided by the contractor, this pressure is more than 50 percent of the yield pressure of the launch tube and exceeds the requirement of NAVSEAINST 9310.1A. Furthermore, Test 7 did not result in temperatures high enough to cause initiation of the gas generator.

Based on the results described above we conclude that the ADC Mk 3 is acceptable for service use in the shipping configuration. In the launch configuration, it is recommended that a means of pressure relief be provided in the launch tube. After pressure relief is provided in the launch tube, the redesign should be resubmitted to NSWC for review and, if necessary, units supplied for retesting.

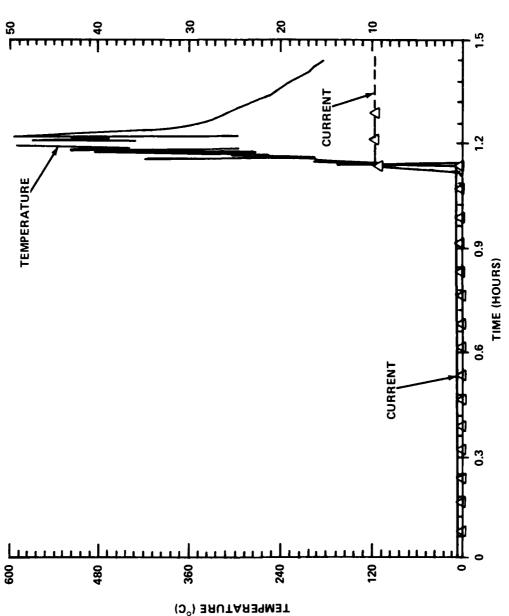
Number 8 used the battery which was forced discharged during Test Number 1. The test was conducted on the battery outside the ADC Mk 3 unit. All fuses were bypassed for Test Number 8. The battery was first discharged completely by placing a 5-ohm resistor across the output terminals. A summary of the discharge is presented in Figure 15. The battery was then charged with a power supply. The voltage and current were limited to the open-circuit voltage (52V) and fuse value of 30 amperes, respectively. The observed currents were in the milliamp range during this test. This test was terminated after approximately 80 minutes. No ventings occurred during this phase. The power supply voltage was then increased to 150 volts to increase the charging current. The current increased to about 1/2-ampere and remained at that level for two minutes. The current then climbed to 13 amperes and cells started to vent. Voltage was then lowered to 52 volts. Current and voltage were erratic. Several violent ventings occurred and the battery burned. A summary of this charging test is presented in Figure 16.

CHARGING OF BATTERY PREVIOUSLY DISCHARGED AS SHOWN IN FIGURE 15 OUTSIDE ADC MK 3 (THE CURRENT AND TEMPERATURE ARE PLOTTED AS A FUNCTION OF TIME. VOLTAGE AND CURRENT WERE VARIED DURING THIS TEST AS DESCRIBED IN THE TEXT.) FIGURE 16.
